CORNER RECORD

COUNTY OF Nevada T. 14N R. 8E Mount Diablo MERIDIAN CALIFORNIA

REPLACED MISSING PROPERTY CORNERS
WESTERN LAKE PROPERTIES SUB.BK.2, PG.103

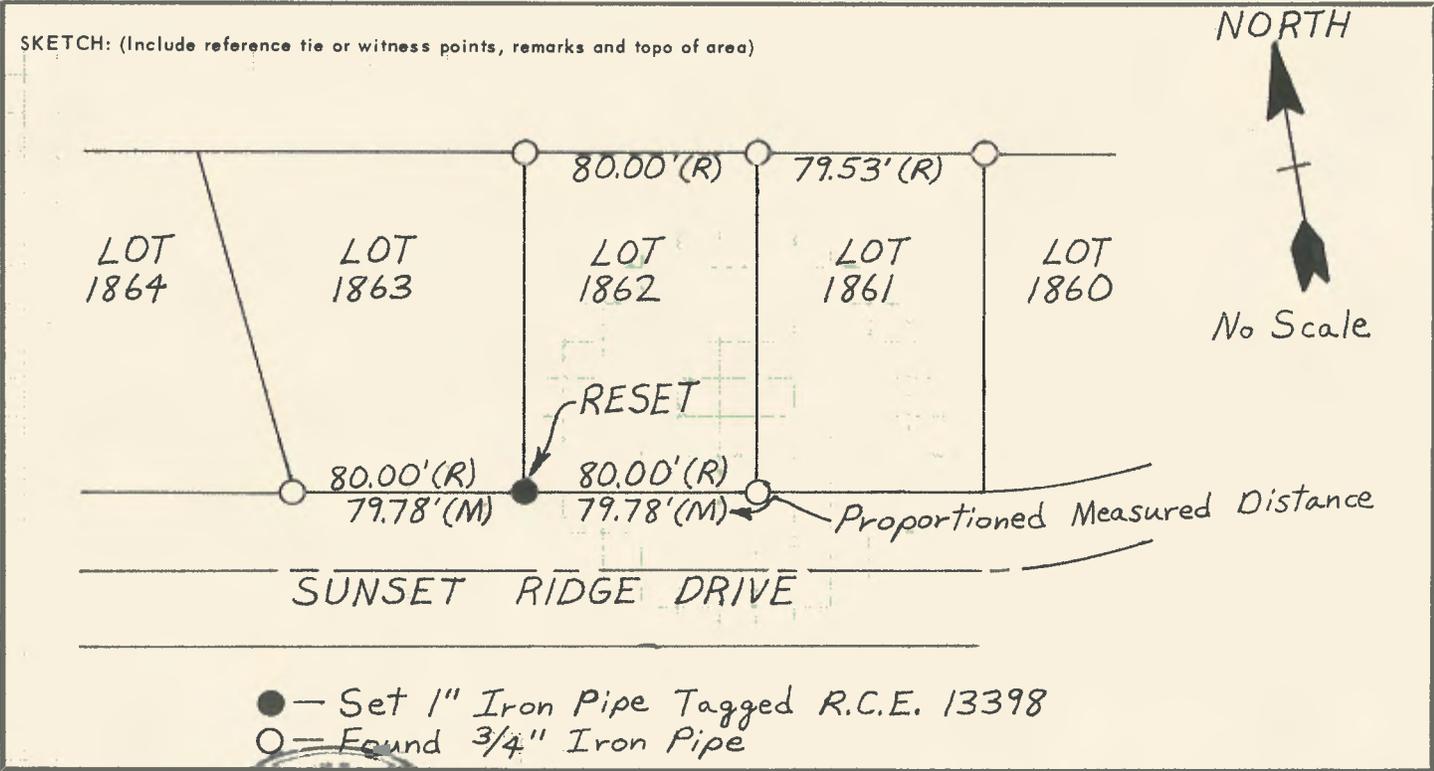
PHYSICAL DESCRIPTION OF CORNER FOUND: EVIDENCE AND METHOD USED TO IDENTIFY OR REESTABLISH We found a 3/4" iron pipe, which had been bent over during construction of a sewer line extension in the approx. location of the corner in question. Used adjacent lot corners, which were found to be in good condition, to reestablish the property corner. Set transit up at the SE corner of Lot 1862 sighting the SW corner of Lot 1863 and pulled 79.78 feet to reestablish the property corner.

PHYSICAL DESCRIPTION OF MONUMENTS REBUILT OR PERPETUATED
Reset corner that was destroyed during construction with a 1" iron pipe tagged R.C.E. 13398.
