**APPENDIX 3.7-A - GEOTECHNICAL  
EVALUATION**

<b>Customer</b> Ananya Choudhuri achoudhuri@pmcworld.com	<b>Consultant</b> William Kenney, CE, GE Principal Engineer William.kenney@acaciace.pro
PMC 1590 Drew Avenue, Suite 120 Davis, CA 95618  Tel 530-601-2501 Fax 530-750-2811	Acacia CE Inc. 3025 Venture Road Placerville, CA 95667  Tel: (530) 748-1336 ext. 15 Fax: (530) 621-4837
<b>SUBJECT:</b>	Rincon del Rio Nevada County, California

**Geotechnical Review**

**GEOTECHNICAL FEASIBILITY STUDY**  
**for**  
**Rincon del Rio**  
**Nevada County, California**

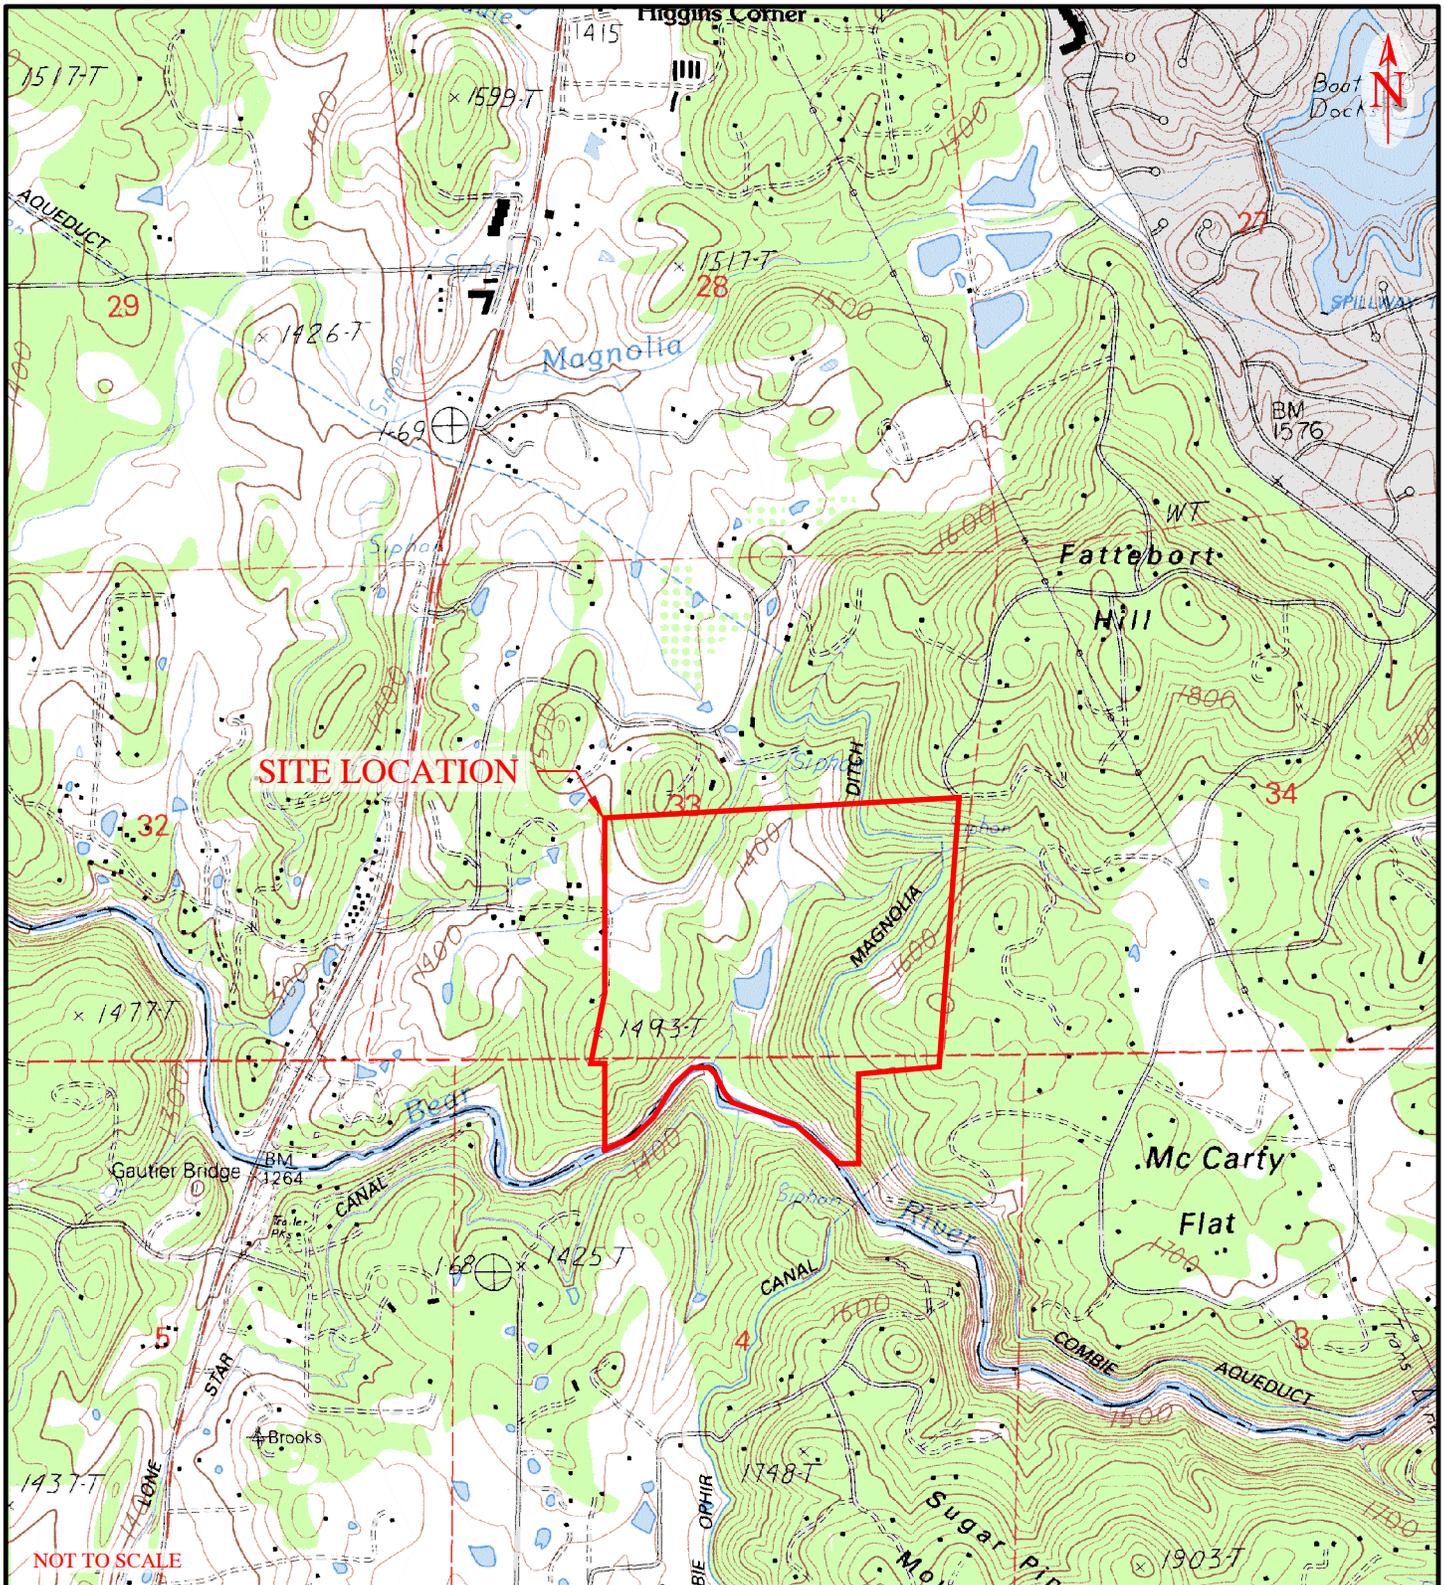
PROJECT NO.	AC106	FIGURE NO.
DATE	JUNE 2011	<b>3</b>
REVISION	0	
DRAWN	DS	
CHECKED BY

LAKE COMBIE QUADRANGLE 7.5 MINUTE TOPOGRAPHICAL MAP

PRODUCED BY THE UNITED STATES GEOLOGICAL SURVEY  
 CONTROL BY ..... USGS  
 COMPILED FROM AERIAL PHOTOGRAPHS TAKEN ..... 1987

**RINCON DEL RIO**  
 CONTINUING CARE RETIREMENT CENTER  
 HISTORICAL TOPOGRAPHIC MAP

- 25 A. The Project site features varied topography, including rolling hills with somewhat flatter terrain in  
26 the central area.
- 27 B. Based on the USGS topographical map, elevations within the site range from about 1,300 feet  
28 above mean sea level (msl) near the Bear River to approximately 1,700 feet above msl near on the  
29 eastern side of the site (Figure 3).
- 30 C. The Project site is currently sparsely developed. Current development includes:

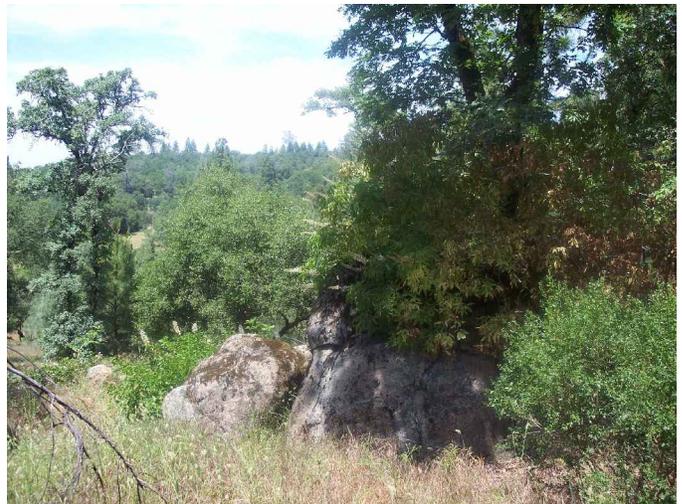
ROCK OUTCROP LOCATED  
IN THE NORTH WEST AREA  
OF THE SITE

56   Numerous rock outcrops are located throughout the site. Rock outcrops as shown in Figures 4.2 and 4.3

57   are indicative of massive unweathered rock that can present significant excavation difficulty during

58   construction (e.g., grading and underground utility installation, etc.).

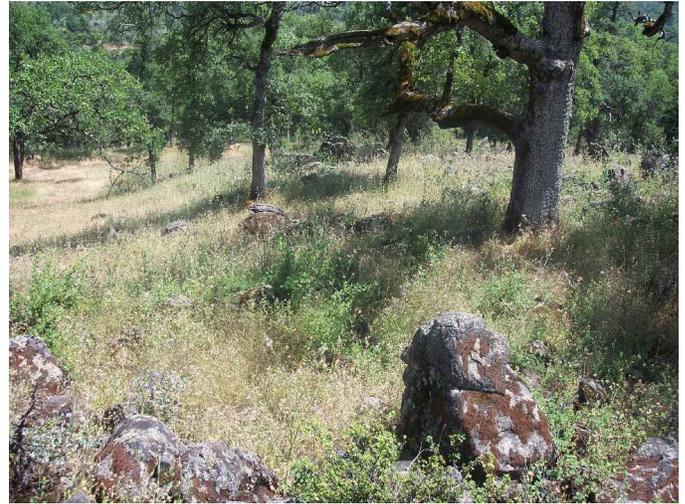
ROCK OUTCROP IN NORTH WEST AREA OF SITE

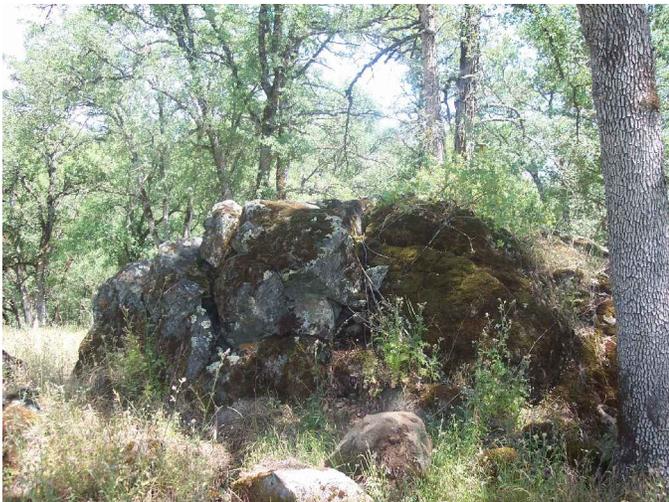
ROCK OPUTCROP IN EAST AREA OF SITE

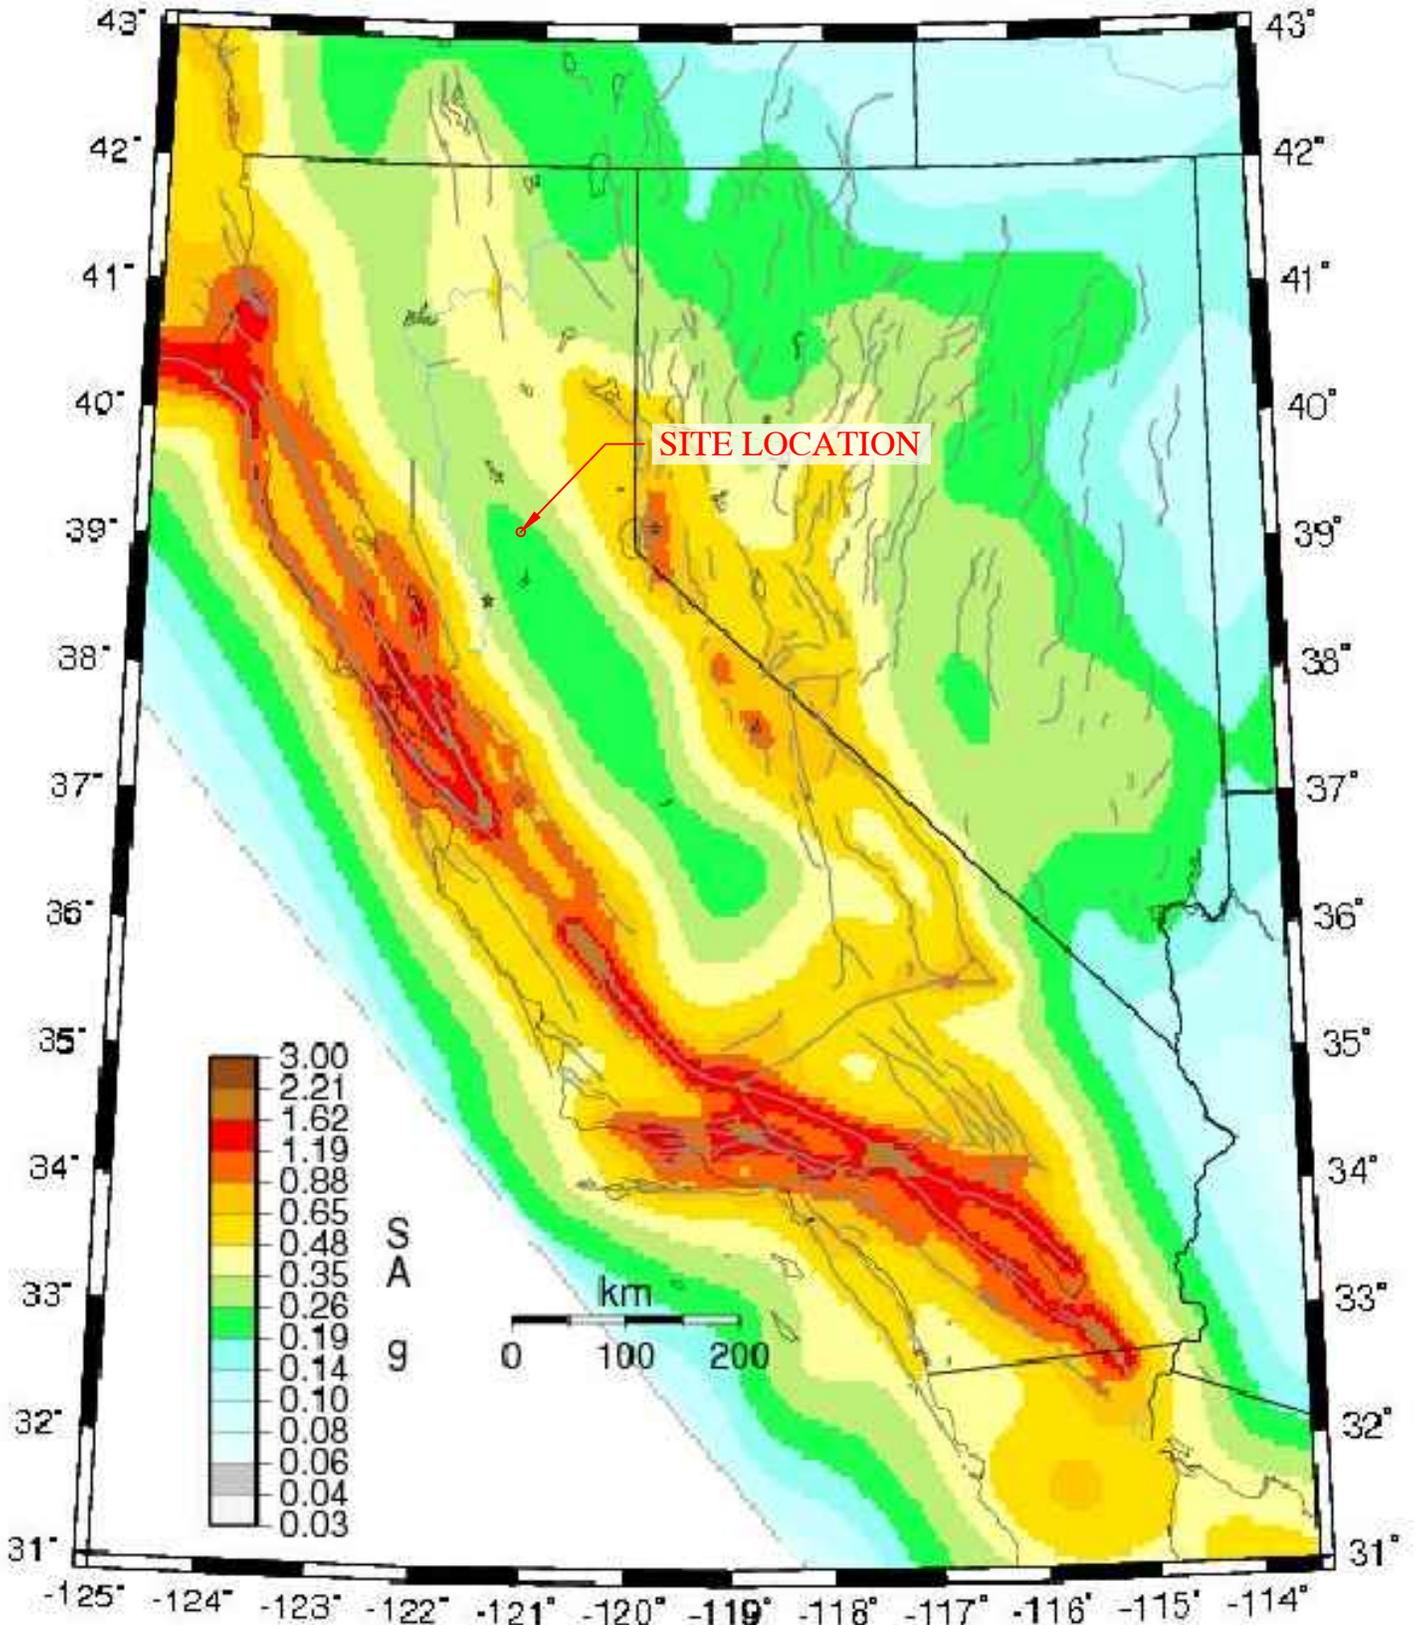
**5.0**

USGS 5-hz SA with 10% in 50yr PE

The closest fault to the site is the Wolf Creek Fault, anticipated ground shaking and intensities should be governed by a design earthquake occurring within 60 miles of the site. Ground shaking intensities may be on the order of a maximum credible earthquake of 6.5 in moment magnitude and a maximum ground acceleration of 0.29g, which corresponds to a ten percent (10%) probability of exceedance in fifty (50) years.

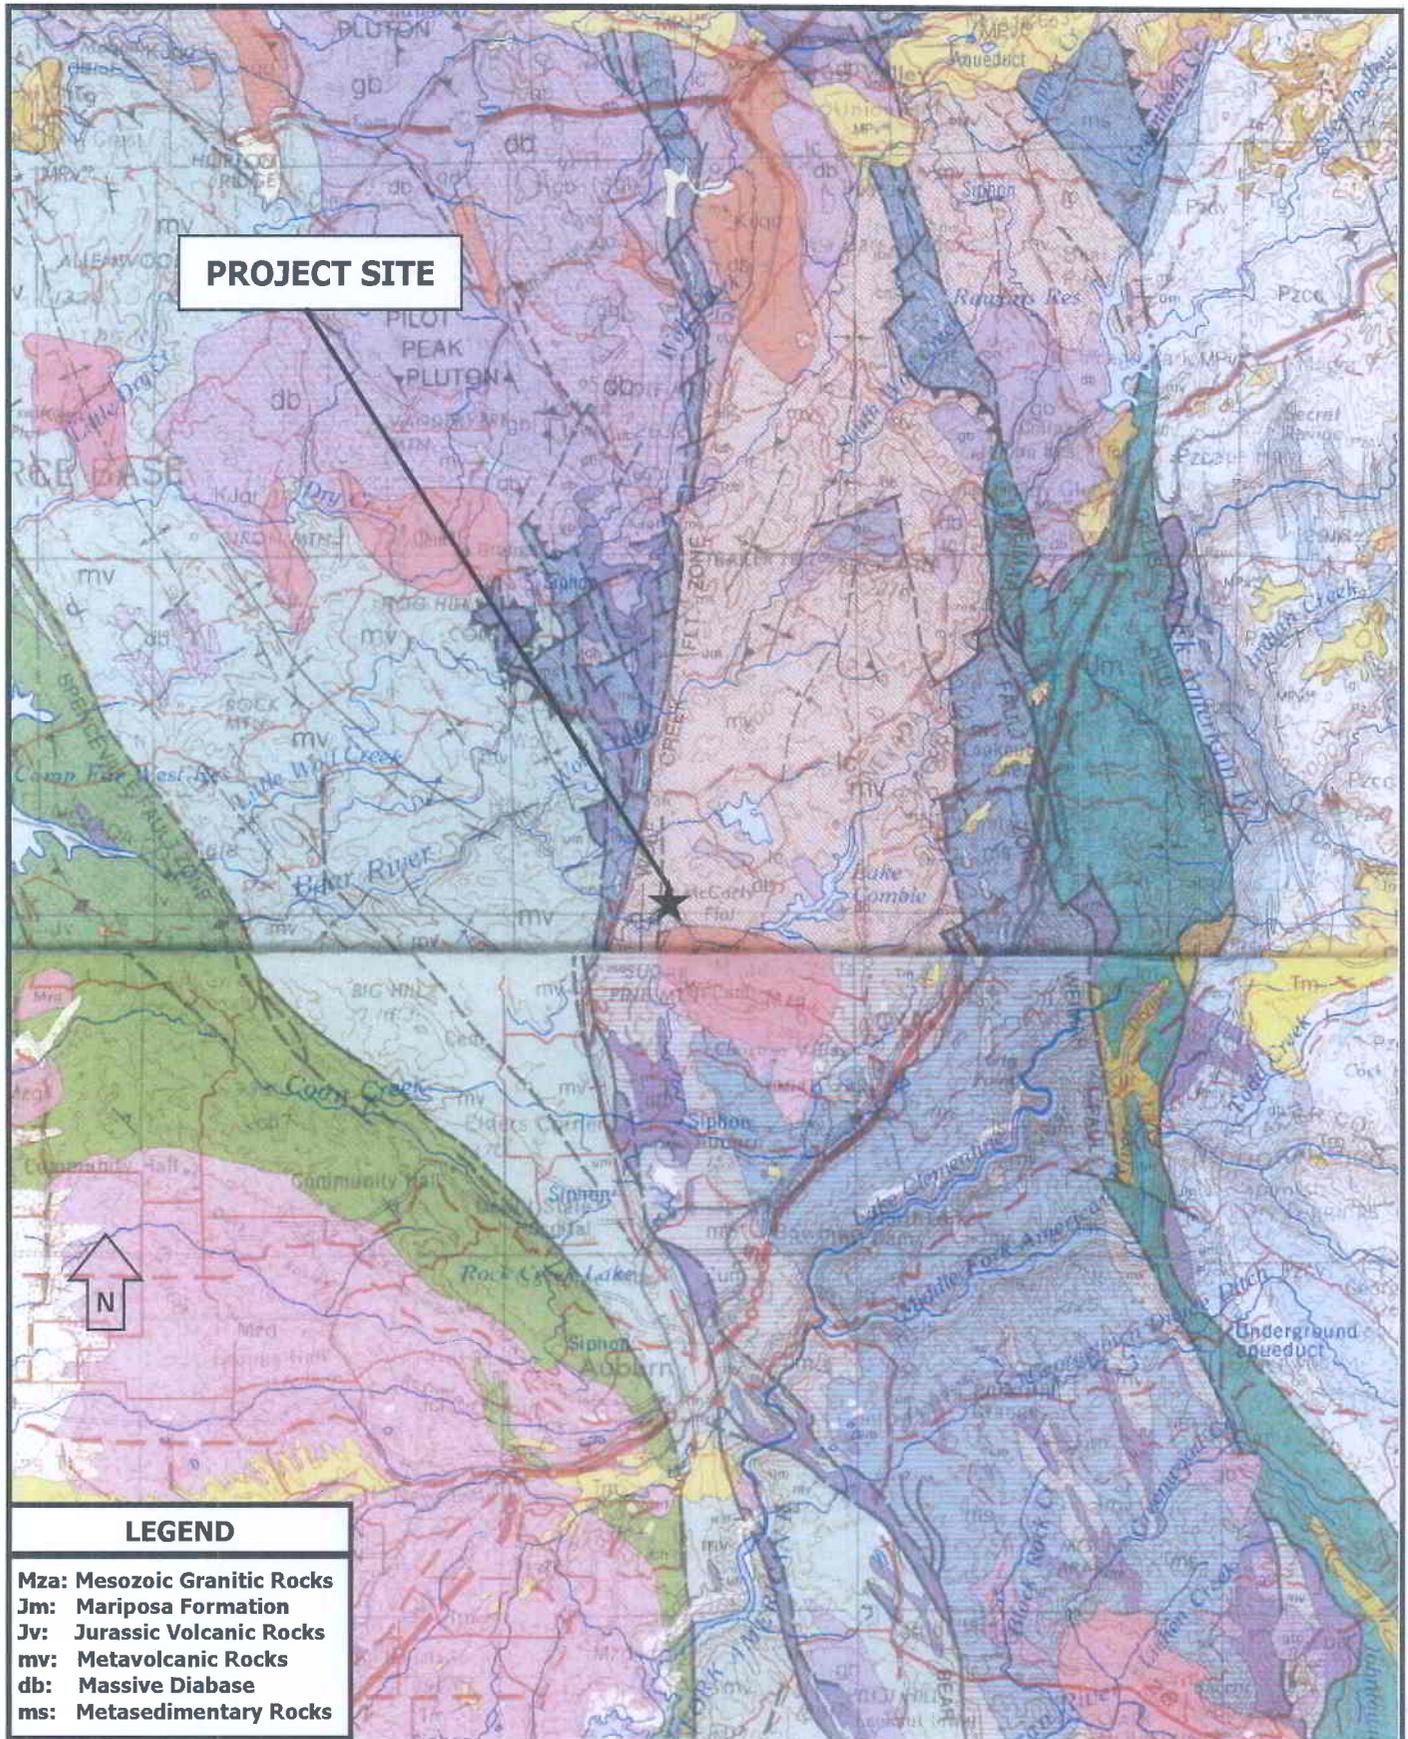
**PLATE**  
**2**

From: Chico Quadrangle, G.J. Saucedo 1992 and Sacramento Quadrangle, D.L. Wagner, 1987.

Rincon del Rio  
**GEOLOGIC MAP**

Our review of geologic maps and site reconnaissance indicates the site is situated between the Wolf Creek Fault Zone and the Weimar Fault Zone, which are components of the Foothills Fault System. Onsite material is dominated by Paleozoic to Mesozoic age mafic metavolcanic rocks (G.J. Saucedo, 1992). A local geology map is provided as Plate 2.

The geologic map of the Chico Quadrangle, California also indicates an approximately located, north trending fault on the property. To the south of the site, this fault juxtaposes Mesozoic age plutonic rocks against Paleozoic to Mesozoic age metavolcanic rocks. This fault is most likely associated with the Wolf Creek Fault Zone to the west.

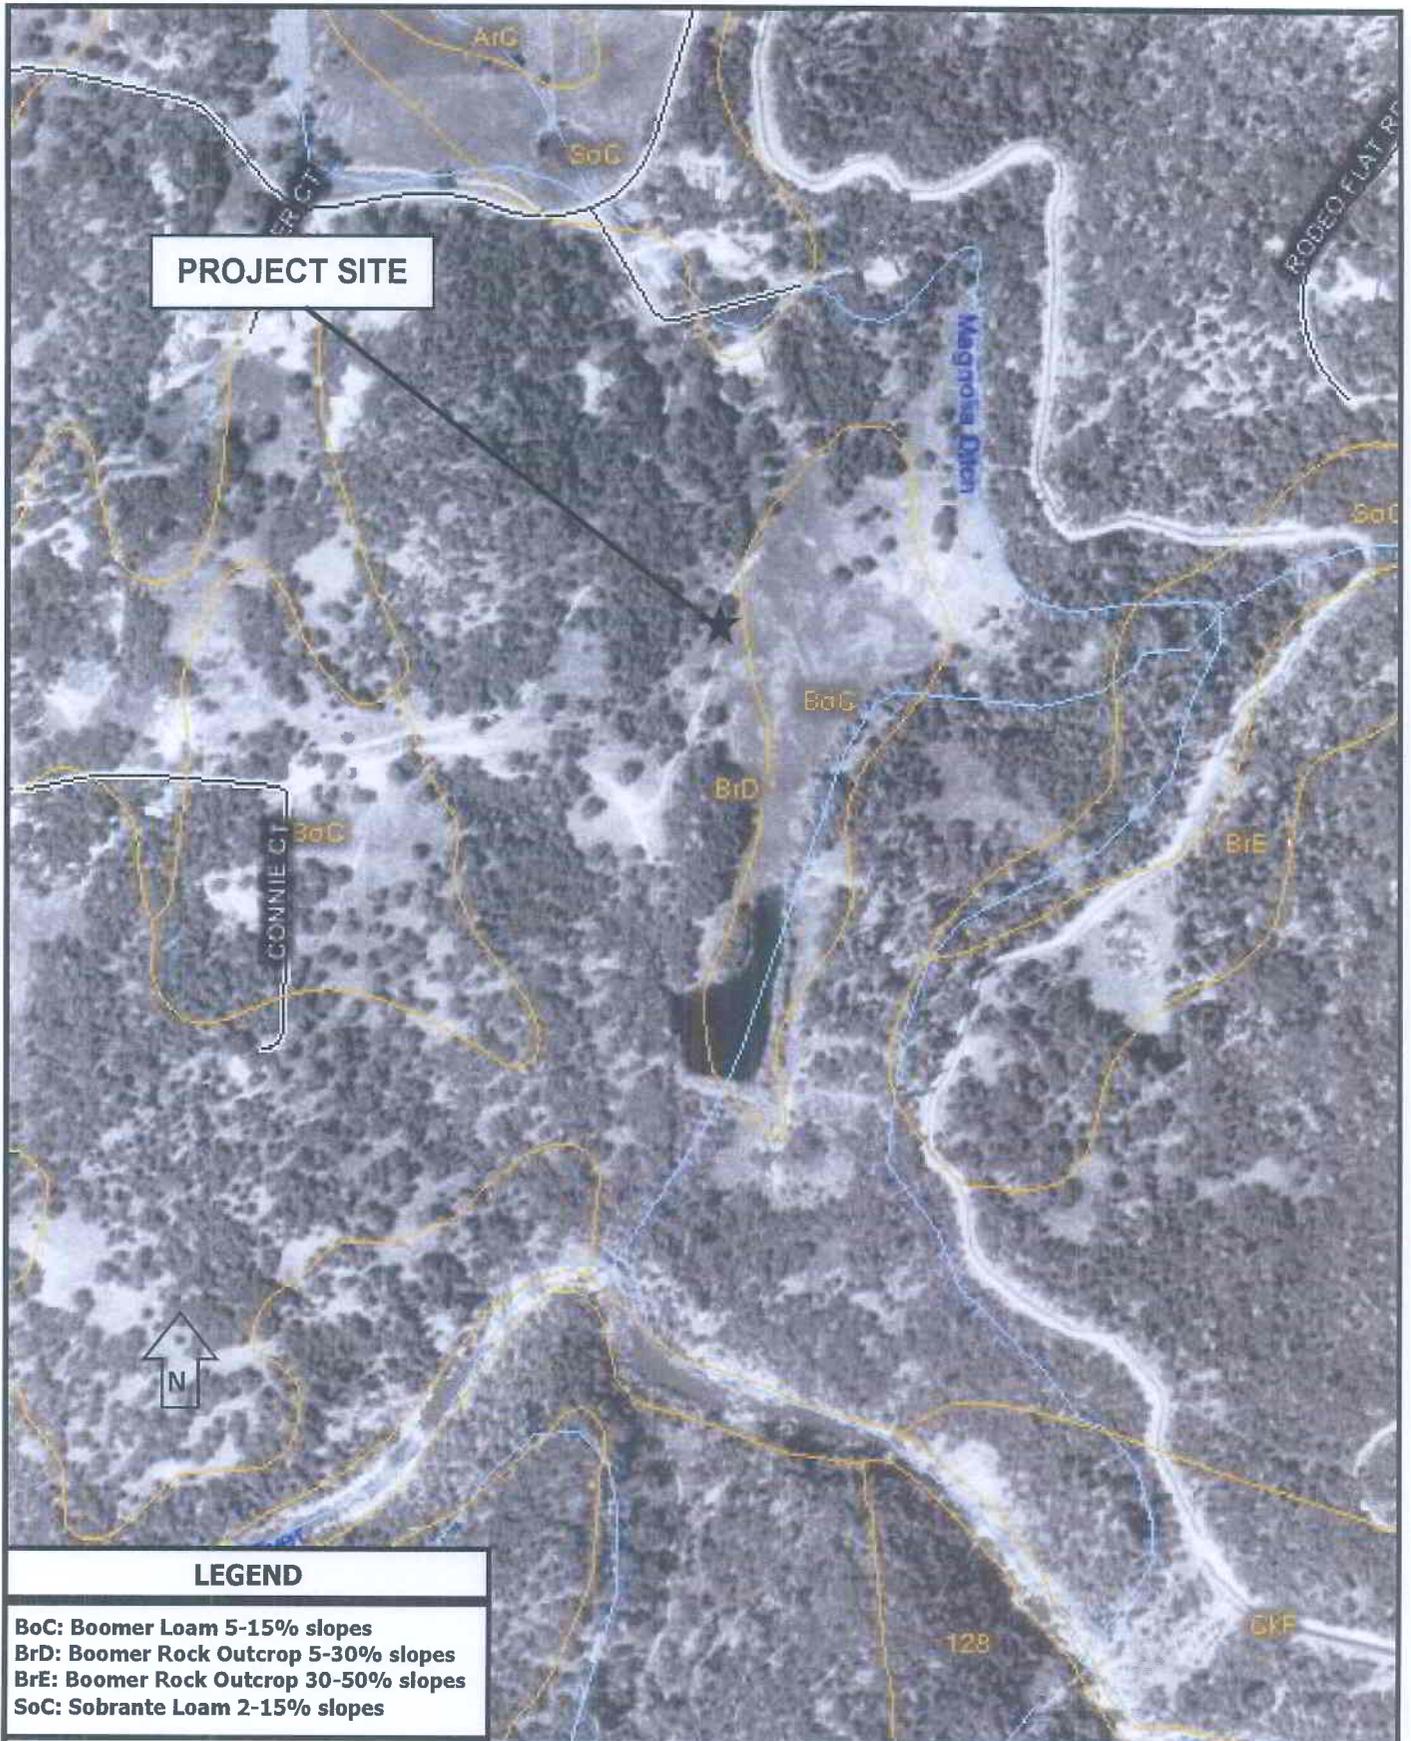
**3**

- BoC: Boomer Loam 5-15% slopes**
- BrD: Boomer Rock Outcrop 5-30% slopes**
- BrE: Boomer Rock Outcrop 30-50% slopes**
- SoC: Sobrante Loam 2-15% slopes**

Rincon del Rio  
**SOILS MAP**

As part of our investigation, Lumos reviewed the web based USDA-NRCS soil survey. The soil survey indicates the project site is underlain by: Boomer series and Sobrante series soils, more specifically: Boomer Loam, Boomer Rock Outcrop and Sobrante Loam. A soils map is provided as Plate 3.

The official soil series descriptions indicate the Boomer series consists of deep and very deep, well drained soils that formed in material weathered from metavolcanic rock. These soils are on uplands and slopes range from 2 to 75 percent. These soils are well drained with slow to very rapid runoff and moderately slow permeability.

The Sobrante series consists of moderately deep, well drained soils that formed in material weathered from igneous and metamorphic rocks. These soils are on foothills and have slopes of 2 to 75 percent.
