PHASE I/II ENVIRONMENTAL SITE ASSESSMENT

BRUNSWICK INDUSTRIAL SITE

GRASS VALLEY, CALIFORNIA

JUNE 16, 2020

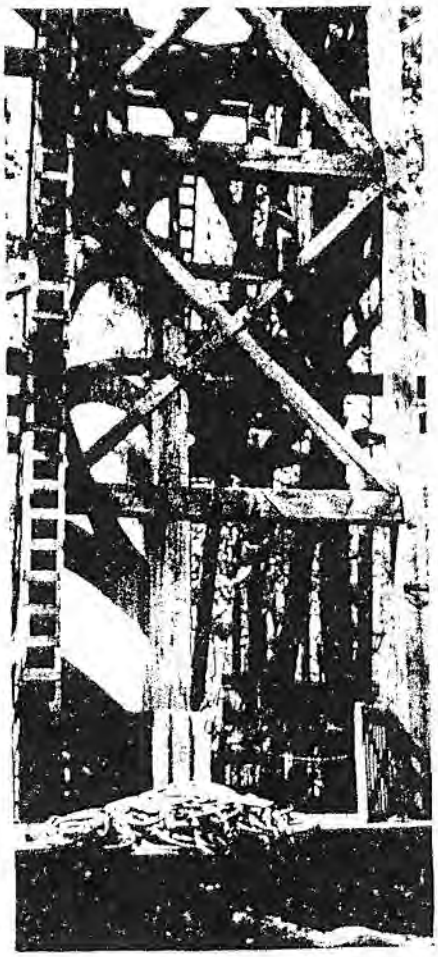
DRIVE HEAD and core barrel hoisted above the shaft collar and suspended in the headframe. Detachable cutting shoes were originally fixed at the bottom edge of the barrel. They failed, however, and were replaced by a solid cutting ring riveted in place

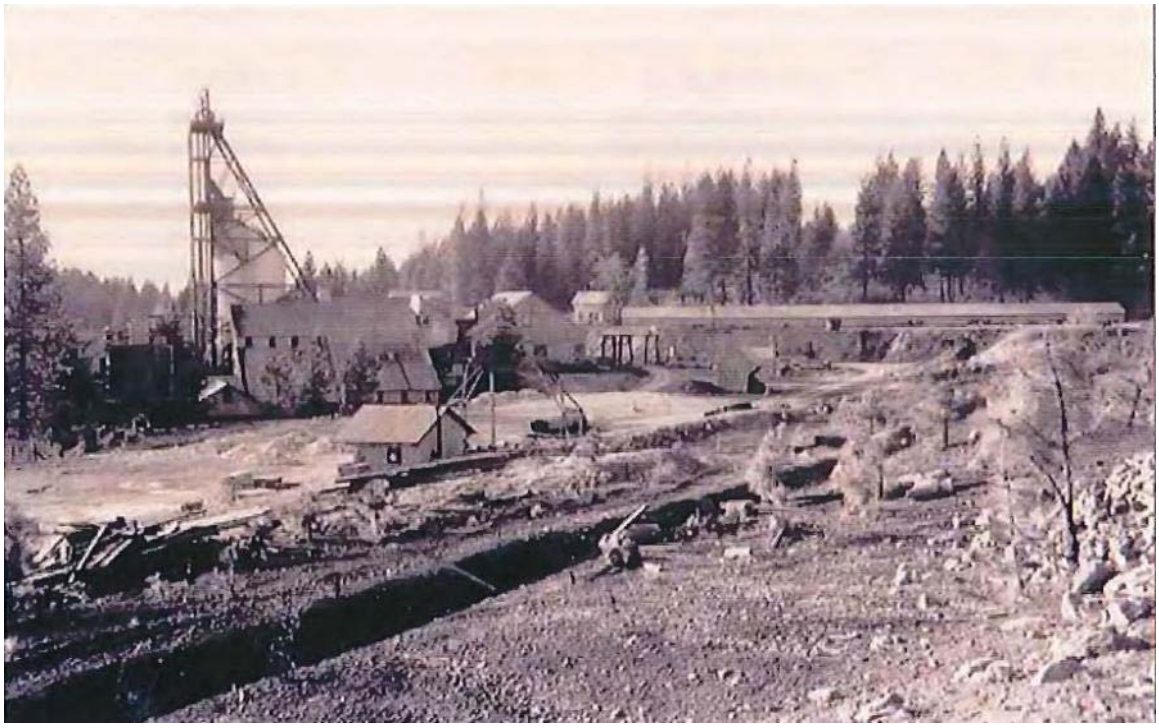
Photo 5. Historical head frame and mining structures viewed from southeast.
