NEVADA COUNT ENERGY EFFICIENCY AND SOLAR PROJECT

Land Use Permit Construction and O&M Narrative

November, 2015

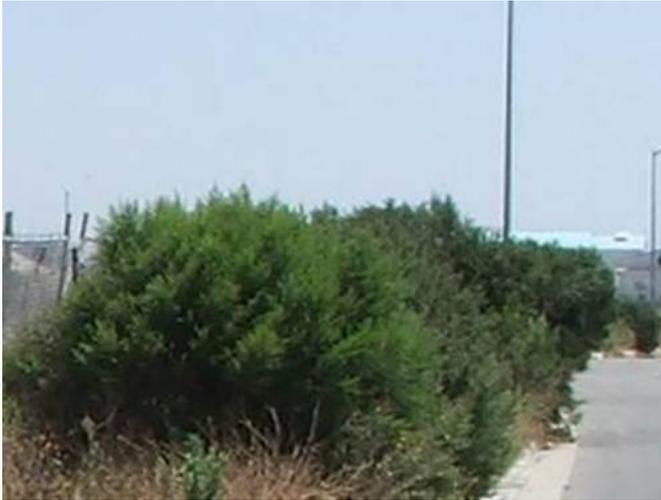
Figure 1: PV Array Located at 16782 HWY 49, Nevada City, CA 95959

The Ranch property PV system will have a visual landscape barrier planted along HWY 49 to minimize the visual impact of the ground mount 1.2MWp solar PV system.

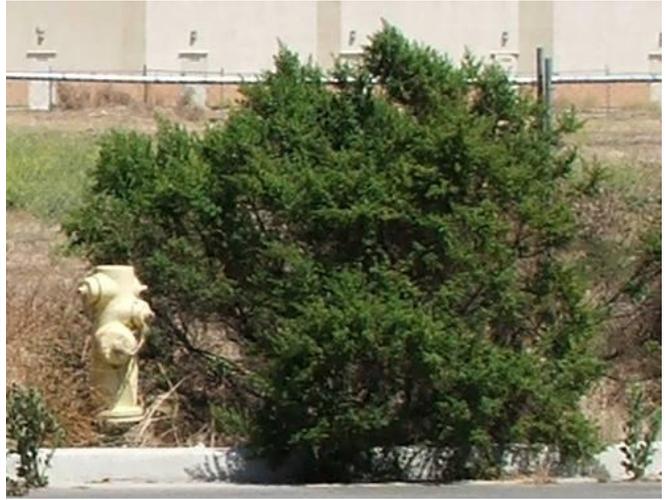
Figure 2 *Baccharis pilularis consanguinea*, Coyote Brush

The identified plant species is *Baccharis pilularis consanguinea*, also known as Coyote Brush. Coyote Brush is a native hedge to the region and blends in nicely to provide a natural looking aesthetic barrier and often used in northern California because of its drought tolerance, natural occurrence and ability to thrive along roadways.

Typical watering frequency is once per week until established then once per month or so during the first summer. Coyote Brush can mature within 1 to 2 years. At maturity the brush will be 6' to 8' in height and width.
