CORNER RECORD

Document Number 130803.101

Brief Legal Description LOT 117 LAKE OF THE PINES RANCHOS PER 3 SUBDIVISIONS 40 N.C.R. Sec. 3, T13N-R8E, M.D.M.

SKETCH FOR CORNER RECORD
 LOT 117 LAKE OF THE PINES RANCHOS
 BOOK 3 SUBDIVISIONS, PAGE 40 NEVADA COUNTY RECORDS
 Ralph Miller LS 3639 December 2010

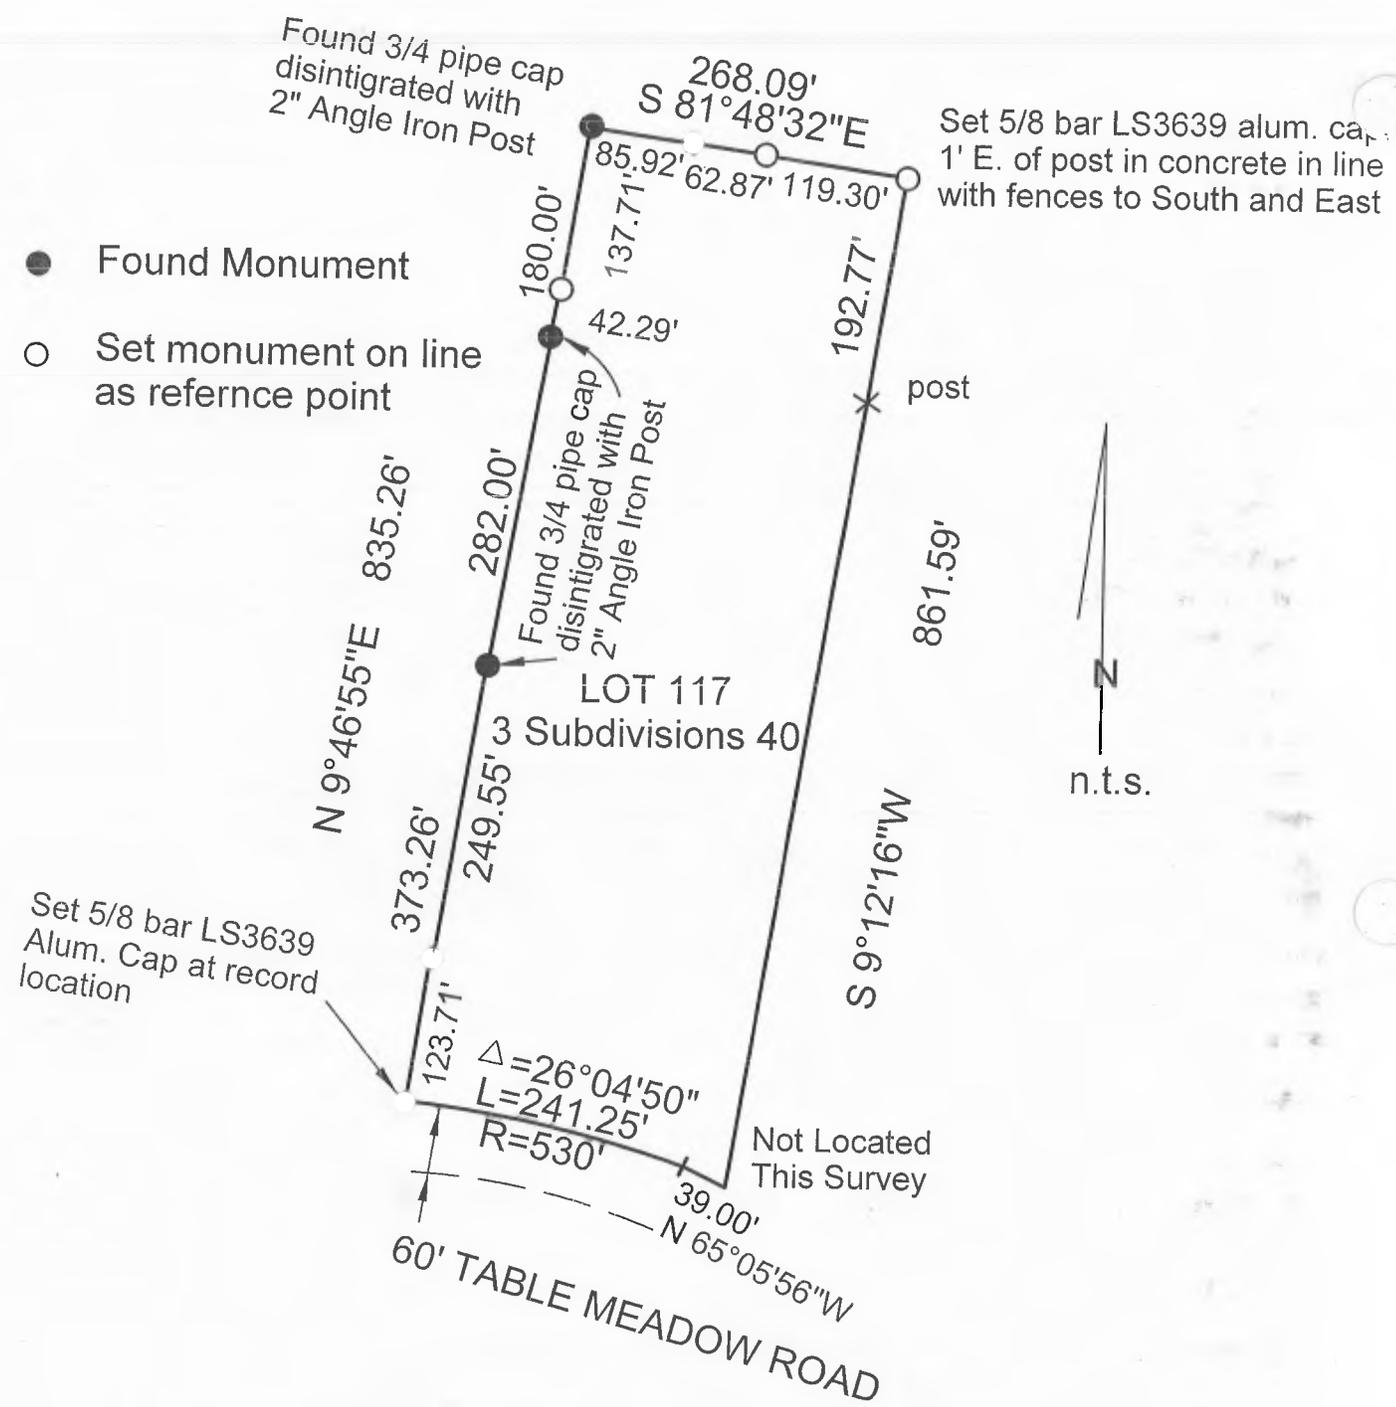
Identification and type of corner found: Evidence used to identify or procedure used to establish or reestablish the corner:
Found monuments on West line of Lot 117 of Lake of the Pines Ranchos per 3 Subdivisions 40 N.C.R. In proper position and as shown on the map. Plastic caps have disintegrated. Each has 2" angle iron guard post.

A description of the physical condition of the monument as found and as set or reset: Monuments found as stated. Reset the Southwest corner with a 5/8 bar and aluminum cap LS3639. Reset Northeast corner with the same type of monument. Set similar monuments on the West and North boundary for inter-visibility.

- Found Monument
- Set monument on line as reference point
